Manhole Inspection Summary

Manhole # S07GG2012MH

Insp Date: **7/6/06 9:20 AM**

Location Address: **6202 PIMILICO RD**

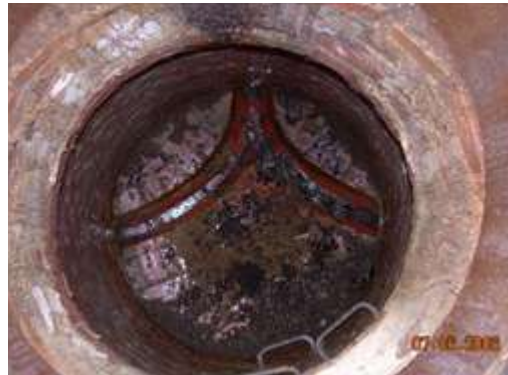
Top View

Adjustment infiltration, Bench debris

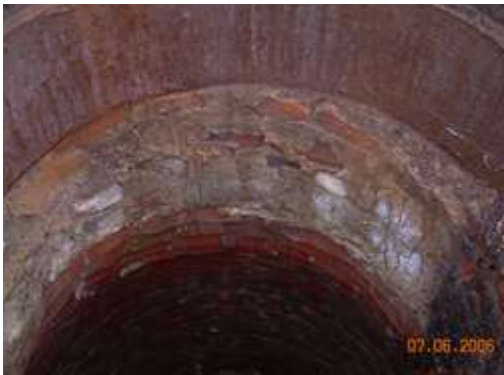
Defect

Parged adjustment, adjustment infiltration, frame leak

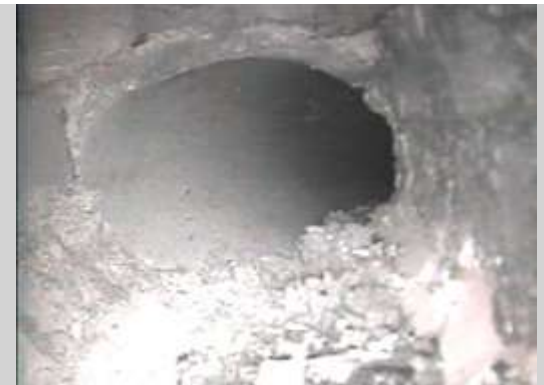
6 in. Circular Gravity Sewer Pipe In @ 3 O'Clock

Deposits: ☐ None ☐ Mud ☐ Sludge ☒ **Debris** ☐ Grease

Silt Depth: **1** (in.) Deposits Extent: **Light**
